Characterizing PCB contamination in Painted Demolition Debris: The "Painted History" at the Iowa Army Ammunition Plant

**Chris Griggs**

**ERDC-EL**

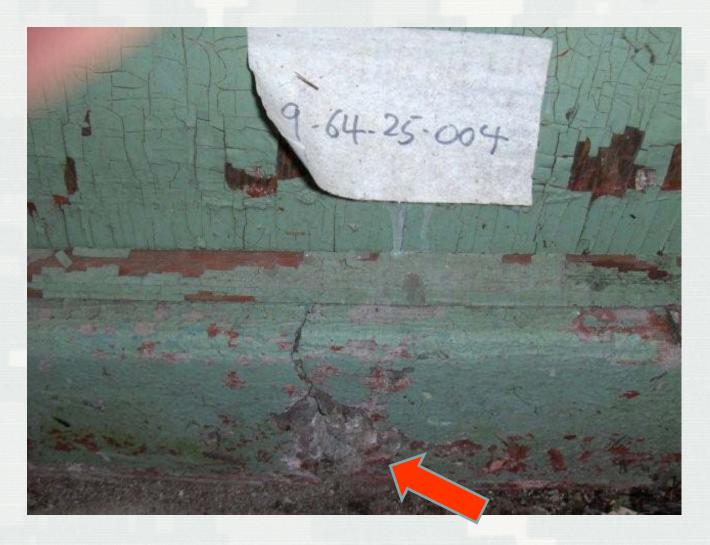
# **2009 Composites Samples Not Representative**

- ➤ The 2008 and 2009 concrete samples were not representative of the waste stream.
- ➤ The 2009 composite sampling report states that 1 inch in diameter by ½ to ¾ inch deep core samples were collected. However, some of these building materials were over 1 foot thick.
- A site visit was conducted to assess the 2008 sampling locations and it was discovered that the substrate samples had only the first couple of milliliters of material collected, apparently by hammer and chisel.

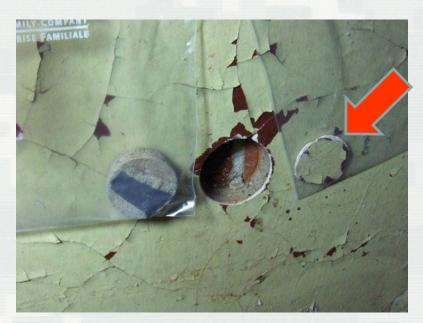
Where surface paint concentrations of 290 mg/kg were observed, only 2 mg/Kg was present in the plaster directly beneath the paint.

gradients in concentration with depth were not observed in the data

- All 2010 substrate sampling results for plaster and concrete are less than 50 mg/kg
- > The 2010 results are orders of magnitude less than the 2008
- Bottom line, no indication of migration
